REPORT NUMBER: FHWA-AZ89-257

SLOPE EROSION CONTROL FOR URBAN FREEWAYS IN ARID CLIMATES

Volume I - Final Report

June 1989

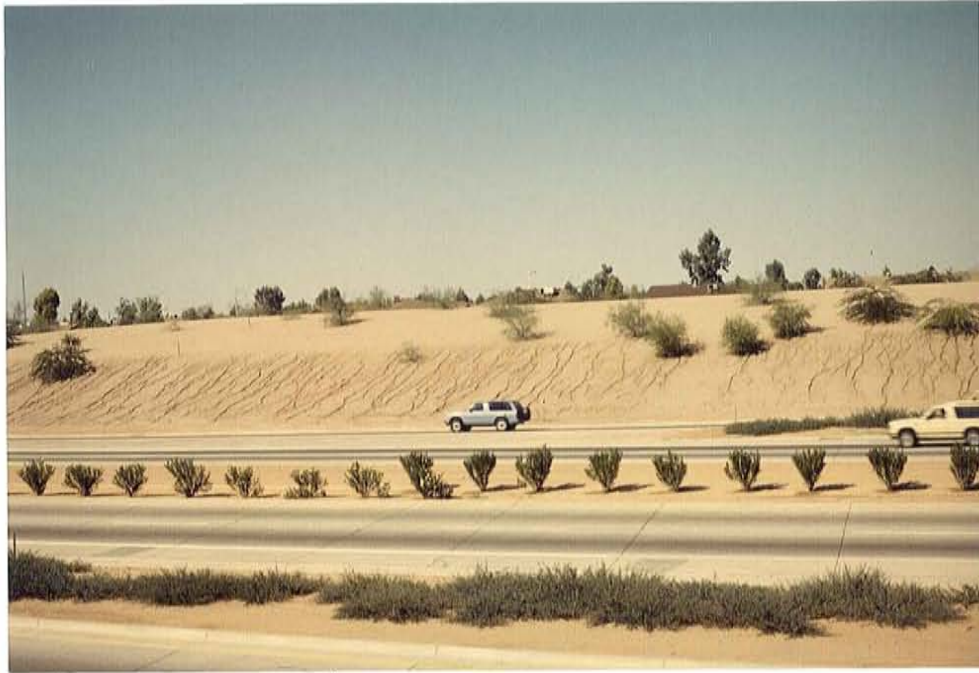
Plate 1. Slope Damage SR 360 West of Gilbert Road.

The planned program was modified, however, as a result of a storm that occurred during October 1986. This storm produced significant erosion damage on several sections of SR 360. The freeway was closed due to slope material that had been washed from the slopes. Slope damage west of Gilbert Road, can be seen on Plate 1.

The study team took the opportunity to examine the slope damage and noticed several phenomena that provided insight into the slope erosion processes. When Plate 1 is examined, the visible erosion pattern is striking. Not only is the density of the rills high but their spacing is remarkably uniform. The rills also start at the same location on the slope. Plate 2 presents a side view showing the rill start point relative to slope curvature.

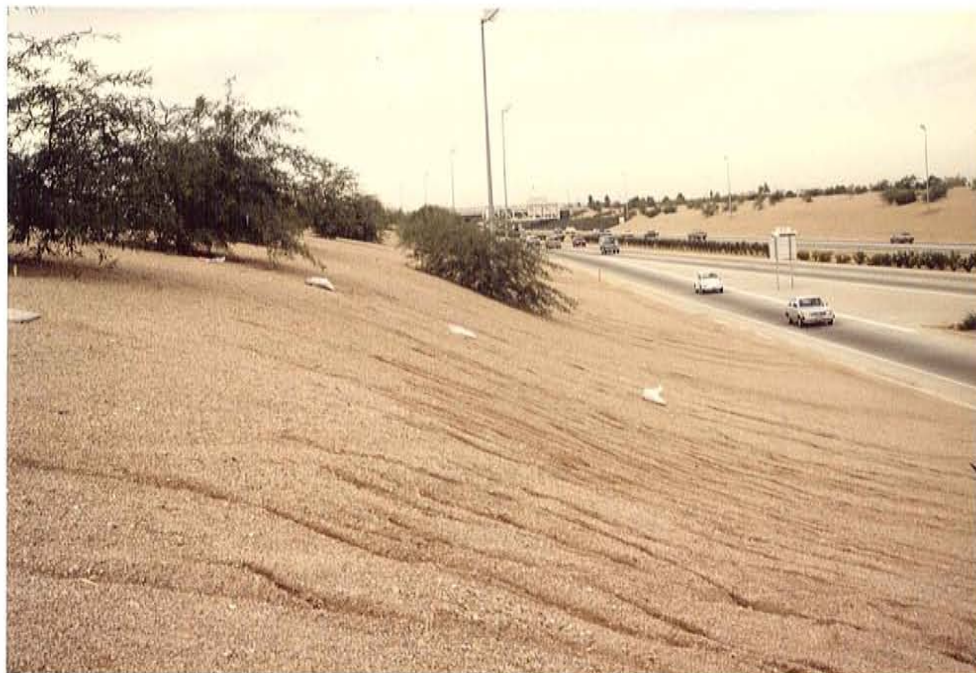
Plate 2. Profile of Slope Erosion Damage, West of Gilbert

The slopes in this section were protected with approximately 0.5 to 1.0 inches of granite slope protection, which when sampled was designated as SRG8 for later reference. The profile of the slope shown in Plate 2 is provided on Figure 2.

The granite thickness west of Gilbert Rd. was less than the original thickness which was supposed to be placed at a thickness of 2.0 inches. During the preparation of the research proposal the study team had noticed that the granite surface protection on most slopes was much thinner than expected. When the eroded slopes were examined, it was discovered that previous rills had been filled by blading the slope granite into them. Earlier storms had cut rills through the original two inch thick protection. These early rills when filled, contributed to the decreasing thickness of the surface protection.

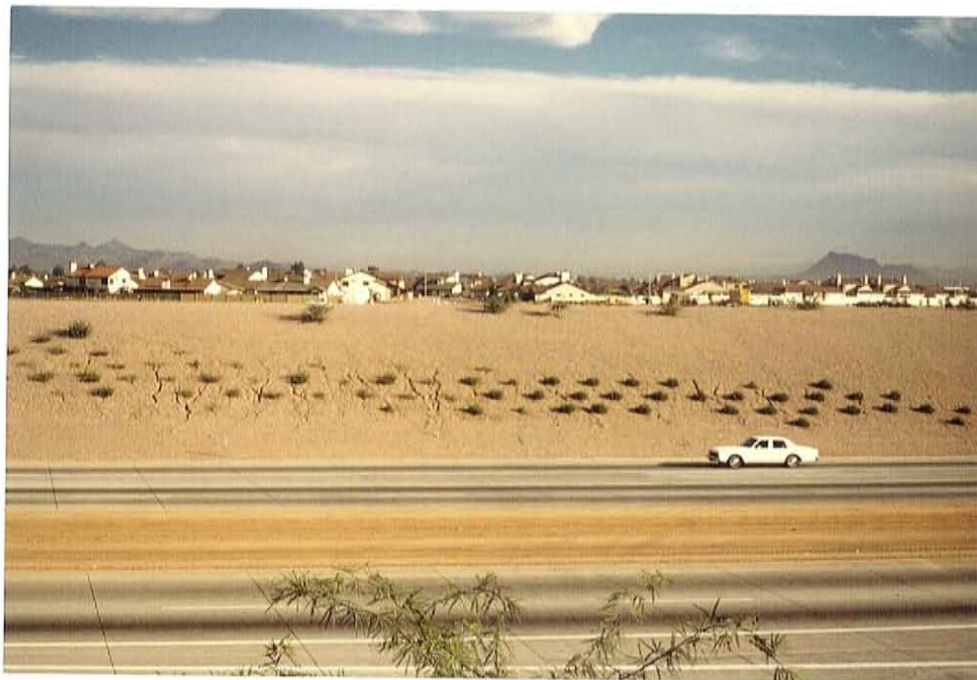
Plate 3. Dlope Damage SR 360 West of Val Vista Road.

West of Val Vista Rd. on SR 360 is another example of slope damage as shown in Plate 3. When the plate is examined, it is apparent that the rills exist essentially only in the planted areas. Rills were not found on sections of the slopes where plants had not been placed. The surface protection on these sections as well as where Plate 3 was taken is a granite designated SRG1. This granite was placed in the spring and summer of 1986 and was not only approximately 2 inches thick but also contained larger particle sizes than did the SRG8 mate-

rial. The observations at this location led the study team to suspect that the low density soil beneath the SRG1 material had allowed undermining of that material to occur. In other locations, where a higher density subgrade existed, such rill development was resisted by the SRG1 material.
